Aviation Investigation Final Report

Location:	Houston, Texas	Accident Number:	DCA23LA384
Date & Time:	July 29, 2023, 10:34 Local	Registration:	N641UA
Aircraft:	Boeing 767-322	Aircraft Damage:	Substantial
Defining Event:	Hard landing	Injuries:	202 None
Flight Conducted Under:	Part 121: Air carrier - Scheduled

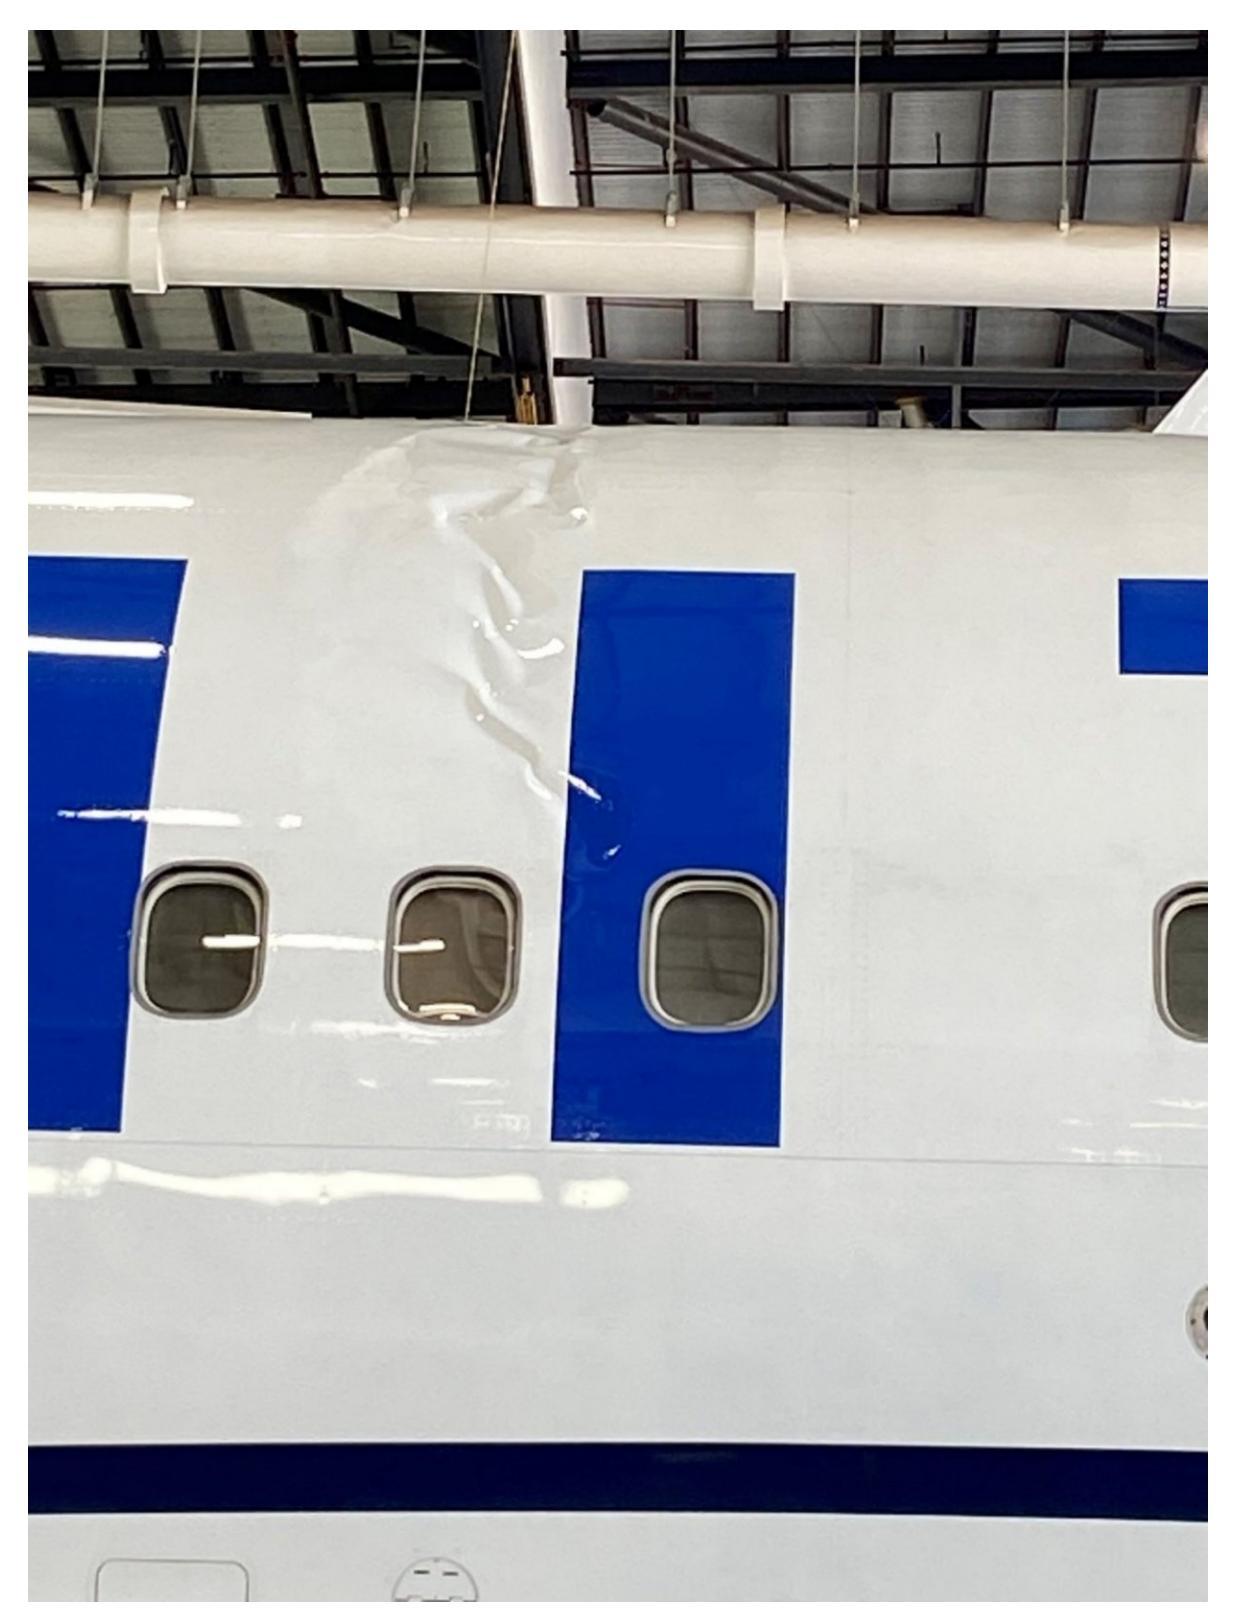
A postaccident examination of the airplane revealed damage to the crown of the upper fuselage. The fuselage skin was buckled and fractured, as shown in figure 1, with damage to the underlying stringers and frames.

Figure 1. Close-up view of the airplane damage on the left side of the fuselage (Source: United Airlines).

These accidents occurred when the pilots applied large nose-down control column deflections after main landing gear touchdown, which resulted in large nose-down pitch rates and high vertical velocities at the nose gear. It was this combination of vertical velocity and pitch rate that resulted in compression loads that exceeded the design loads of the forward fuselage crown structure.

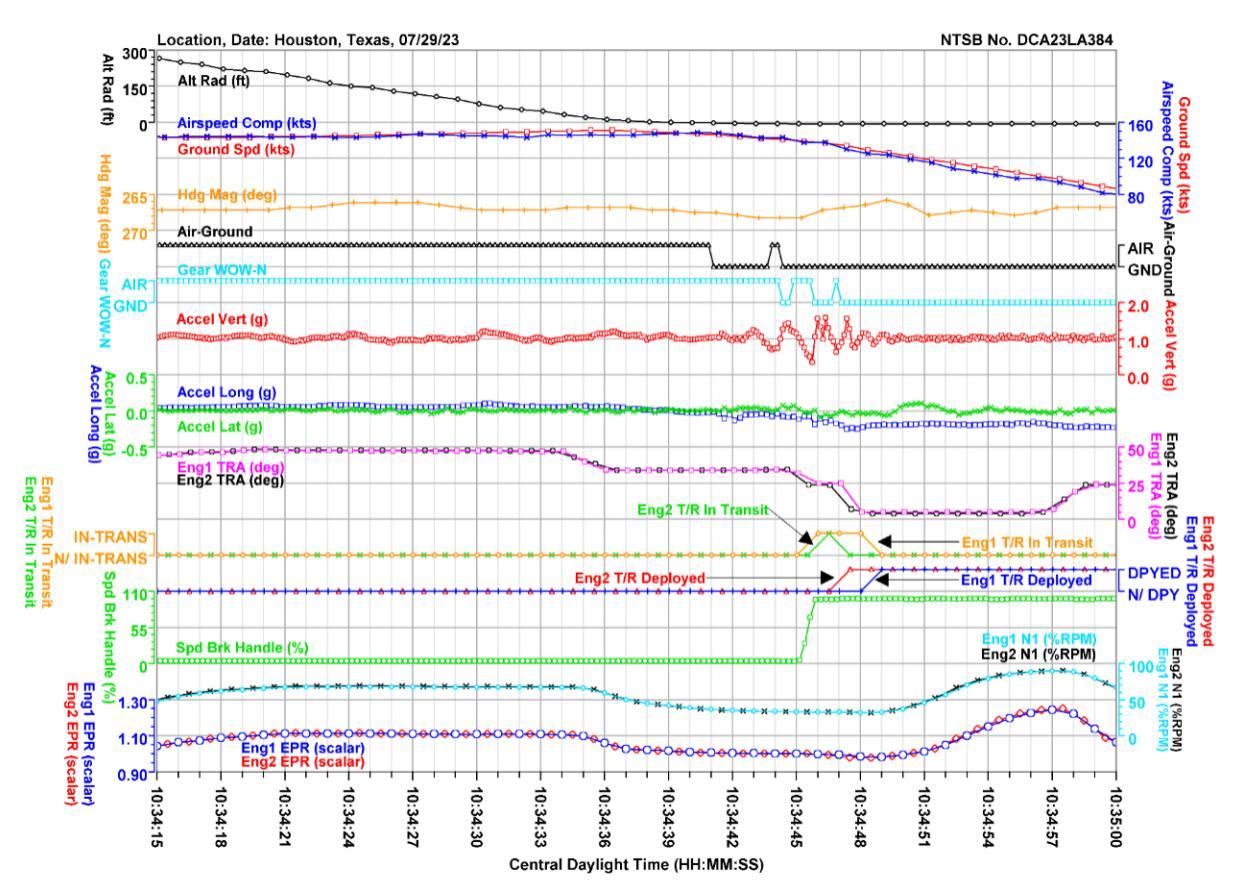
A review of FDR data revealed that the airplane touched down on both main wheels, with a control column position of about 0.35° and the speedbrake handle in the down (unarmed) position. After the initial touchdown, the maximum recorded control column positions during the landing sequence were 5.71° to -4.75°, as shown in figure 2. FDR data also showed that the airplane rolled to the left and that the right main landing gear lifted off the runway's surface. Subsequently, the nosewheel impacted the runway with a force equivalent of about 1.4 gravitational force equivalent (G). The thrust reversers were in transit as the speedbrakes deployed, and the nosewheel impacted the runway a second time with a force of about 1.6 G and bounced. Subsequently, the nosewheel impacted the runway a third time with a force of about 1.6 G.

Figure 2. FDR data pertinent to the circumstances of this accident.
