Aviation Investigation Preliminary Report

Location:	Boca Raton, FL	Accident Number:	ERA25FA173
Date & Time:	April 11, 2025, 10:23 Local	Registration:	N8930N
Aircraft:	Cessna 310R	Injuries:	3 Fatal, 1 Minor
Flight Conducted Under:	Part 91: General aviation - Personal

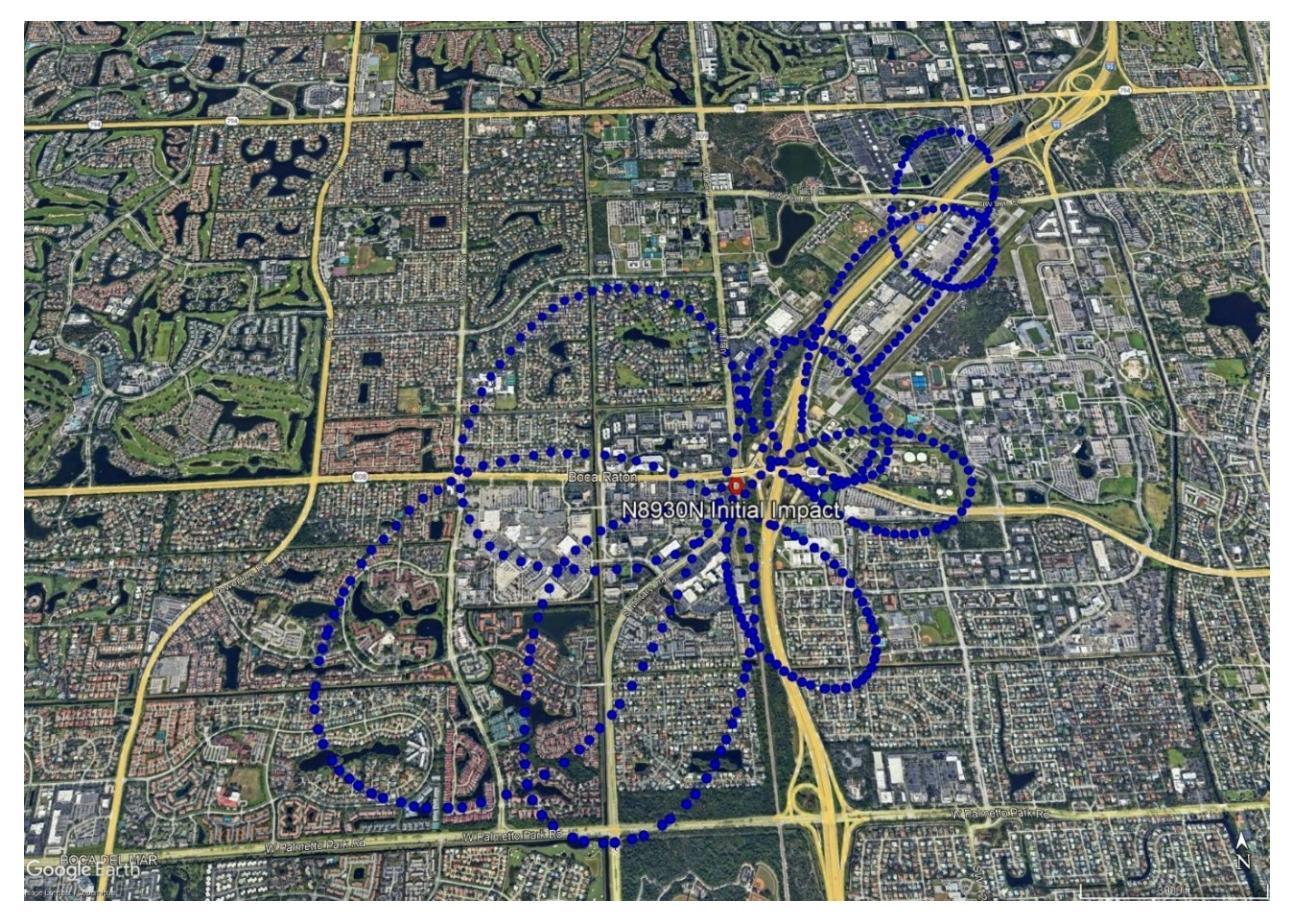
Figure 1. Preliminary ADS-B Flight Track with initial impact point marked.

Preliminary ADS-B data revealed that immediately after takeoff, at 1012, the airplane drifted to the left, followed by a left 180° turn, followed by a left 360° turn. The airplane continued making several left 360° turns; the last data point was on the airplane's 9th turn at 1022 and was 273 ft south of the initial impact point. According to preliminary air traffic control recordings, one of the pilots reported that they were having a problem with the airplane's rudder and that they could only make left turns.
