Aviation Investigation Preliminary Report

Location:	Portland, OR	Accident Number:	DCA24MA063
Date & Time:	January 5, 2024, 17:14 Local	Registration:	N704AL
Aircraft:	Boeing 737-9	Injuries:	177 None
Flight Conducted Under:	Part 121: Air carrier - Scheduled

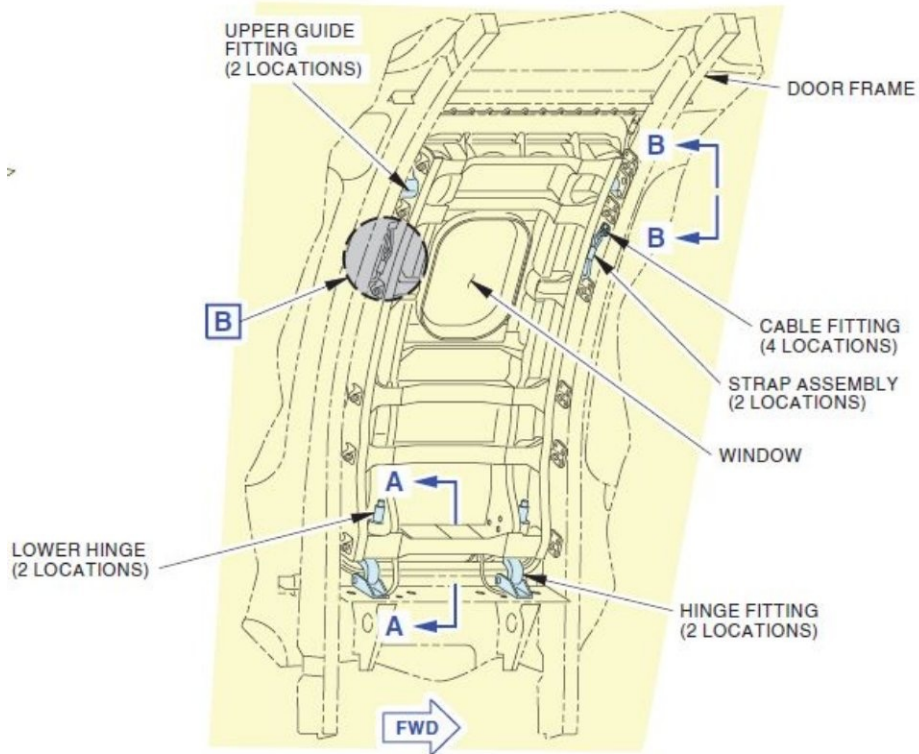
The MED plug is primarily constructed of aluminum and is installed in the fuselage by means of two upper guide fittings and two lower hinge fittings (see figures 4 and 5). The two upper guide fittings are located on the upper sides of the plug and engage with two upper guide rollers that are fixed to the upper sides of the fuselage opening (see figure 6). Two lower hinge guide fittings are fixed to the lower section of the plug and engage with the two lower hinge fittings that are attached to the bottom of the fuselage opening at the lower hinge bracket assemblies.

Figure 4. 737-9 Mid Exit Door Plug. (Source: Boeing. Image Copyright © Boeing. Reproduced with permission.)

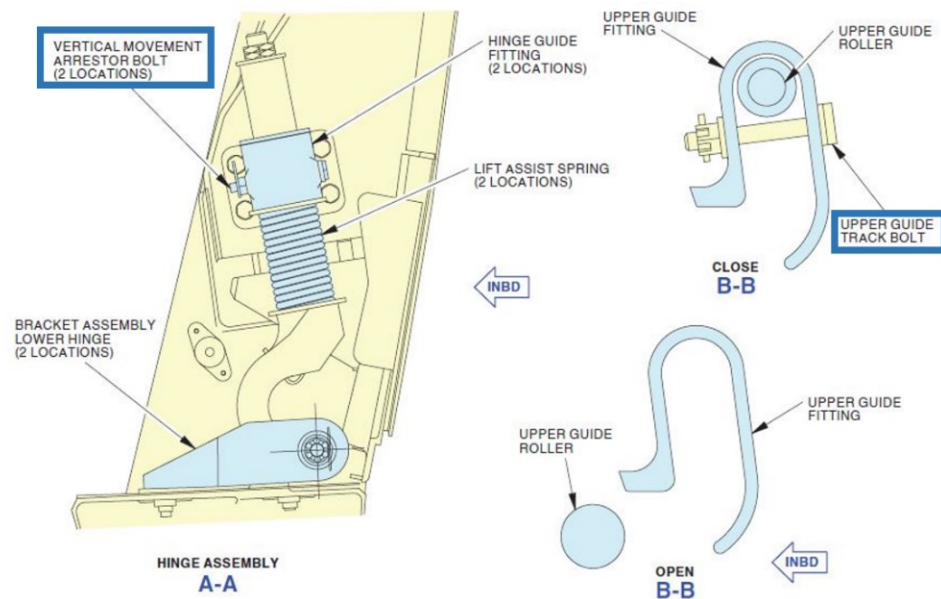
Figure 5. 737-9 Mid Exit Door Plug – Arrestor and Track Bolts. Boxes added for emphasis. (Source: Boeing. Image Copyright © Boeing. Reproduced with permission.)

The two vertical movement arrestor bolts, two upper guide track bolts, forward lower hinge guide fitting, and forward lift assist spring were missing and have not been recovered. See figure 5 for example of installed locations.

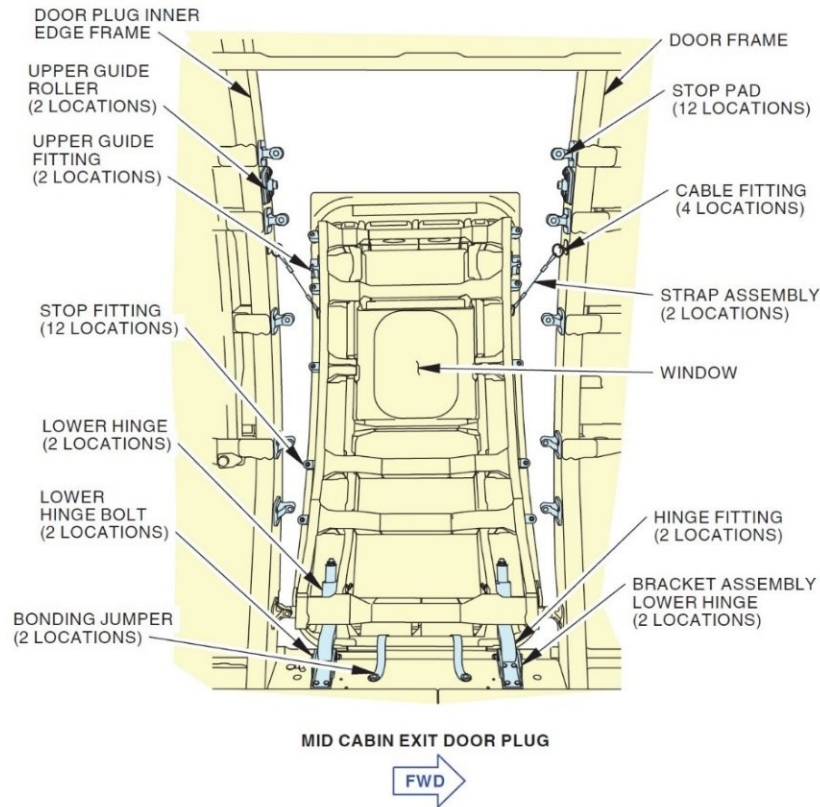
The door plug is only intended to be opened for maintenance and inspection, which requires removing the vertical movement arrestor bolts and upper guide track bolts. The strap assemblies below the second stop pad from the top restrict the plug from opening further than 15°, suitable for maintenance and inspection purposes (see figure 6).

Figure 6. 737-9 Mid Exit Door Plug – Components. (Source: Boeing. Image Copyright © Boeing. Reproduced with permission.)
